Flat roof shatter damage in Germany in spring 2012 refurbishing the damage; requirements for the future

Wolfgang Ernst, President Europäische Vereinigung dauerhaft dichtes Dach e.V.

waterproof membranes 2014

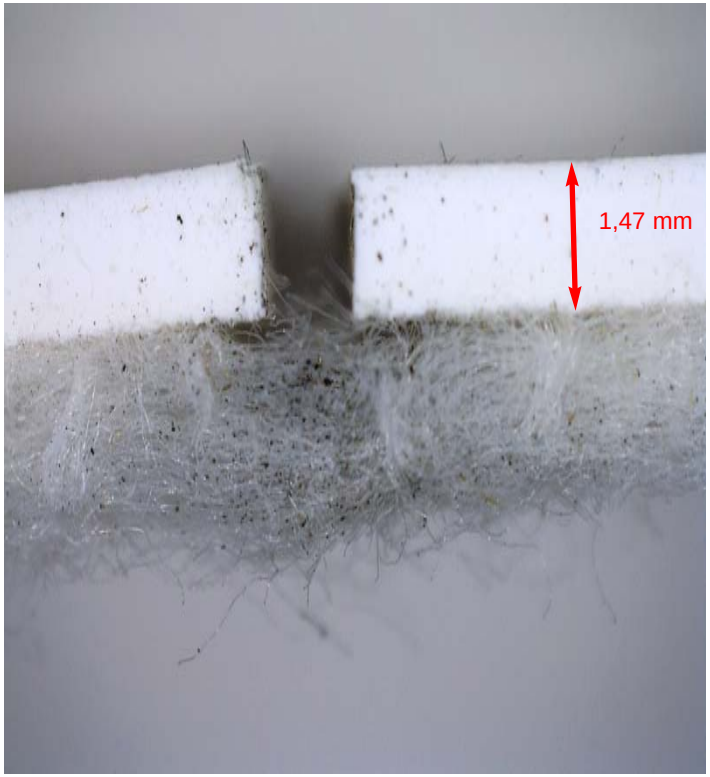
Crack in a unreinforced EVA/PVC-membrane with polyester fleece backing.

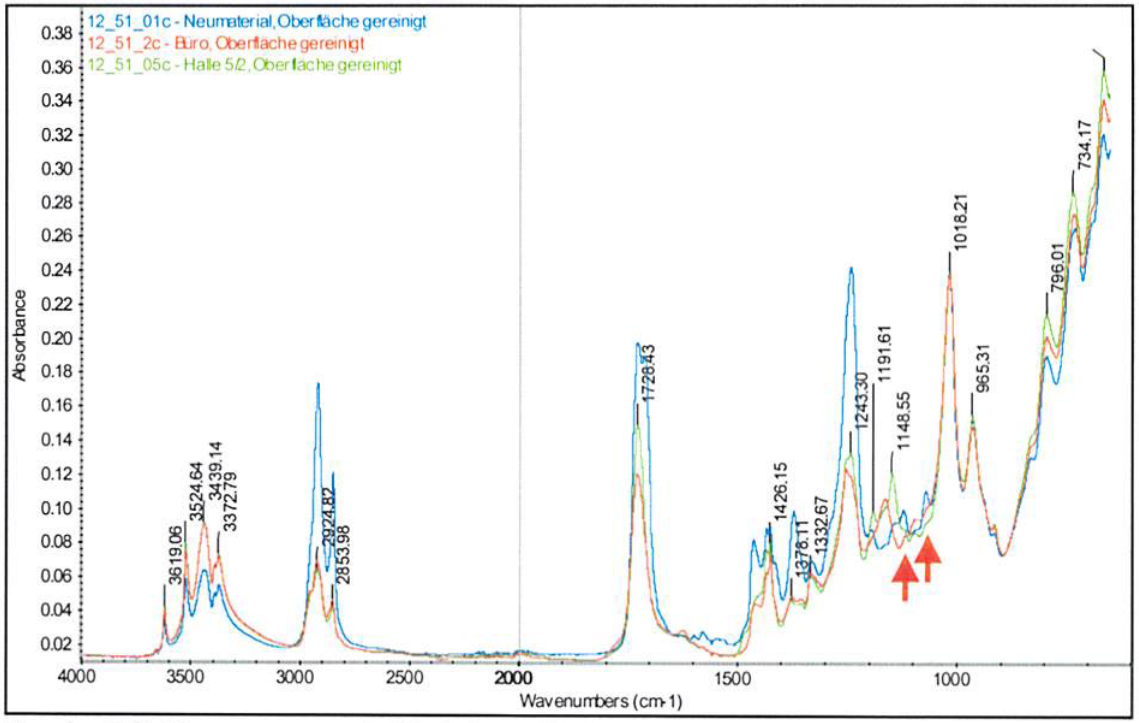
IR-Spectre measurement on surface of the reference sample and on surface of the damaged sheet.

The (enormous) decrease of EVA and increase of additives can be presented and construed as follows:

The material change can be attributed to the hydrolysis susceptibility of the material EVA and the material changes under load to water, lime milk and acid solution of the sheeting respectively - there are clear indications from the test results presented above - Changes in property by standard load in the laboratory.

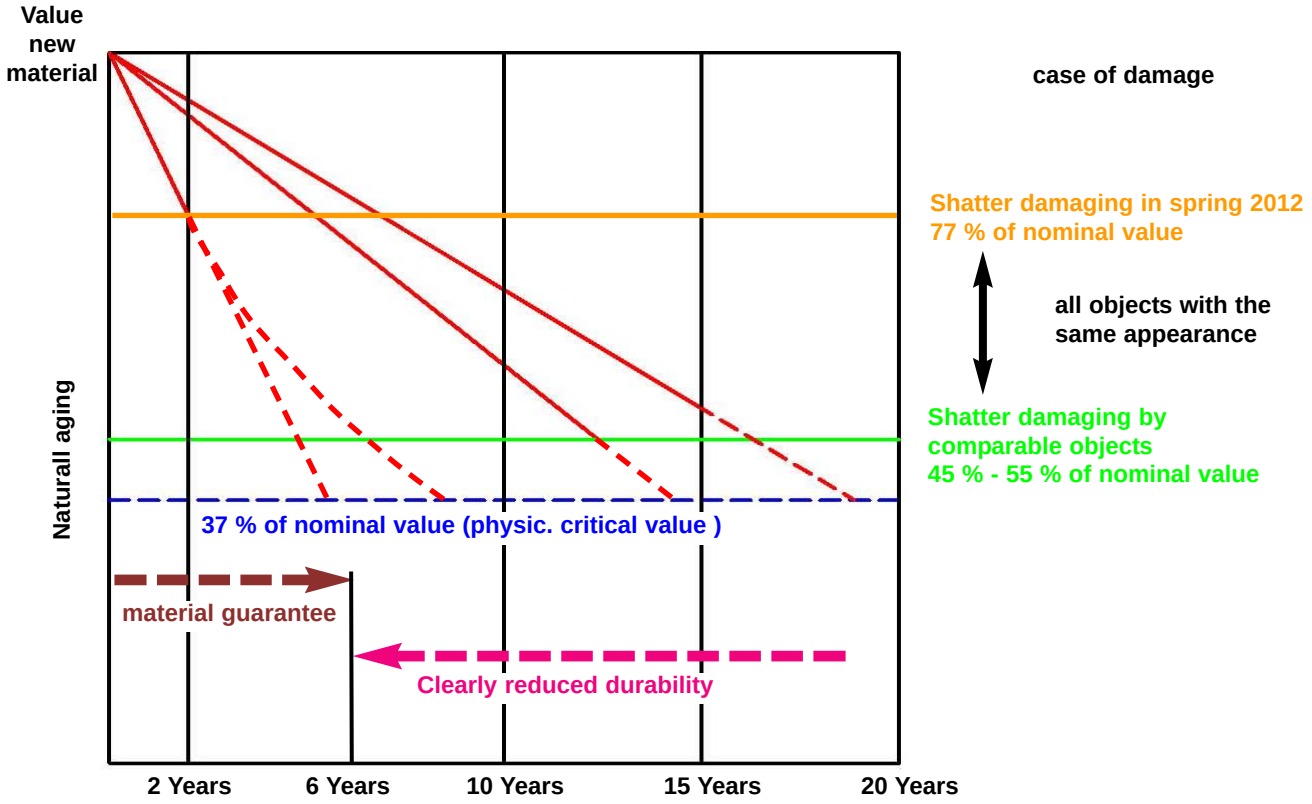
If one considers all test results of the previous years which are available in the laboratory of the signatory regarding the roof sheeting with the designation "DE/E1 EVA-BV-KPV-1.5" from different years of production and comparable objects, forecasts of the expected life span of the sheeting with natural aging behaviour can be presented in a simplified form (linear). The difference of the forecast of sheeting with an older (14 - 18 years) and younger (6 - 8 years) date of production becomes clearly noticeable in this Illustration.

The available test results are directly put in relation to 37 % of the reference value of new material. This reference value is defined as physical limit relevant literature at which the product benefit becomes questionable, e.g. the life span of the product is reached and renovation is necessary.

Illustation 1:
Simple diagram for lifetime with **abstract forecast.**
Clearly reduced durability between sheets from production-year 1998 to 2010.
